# Unitized Curtain Wall Product Renderings

Thermally Broken Aluminum Curtain Wall

**STARLINE**  
**WINDOWS**

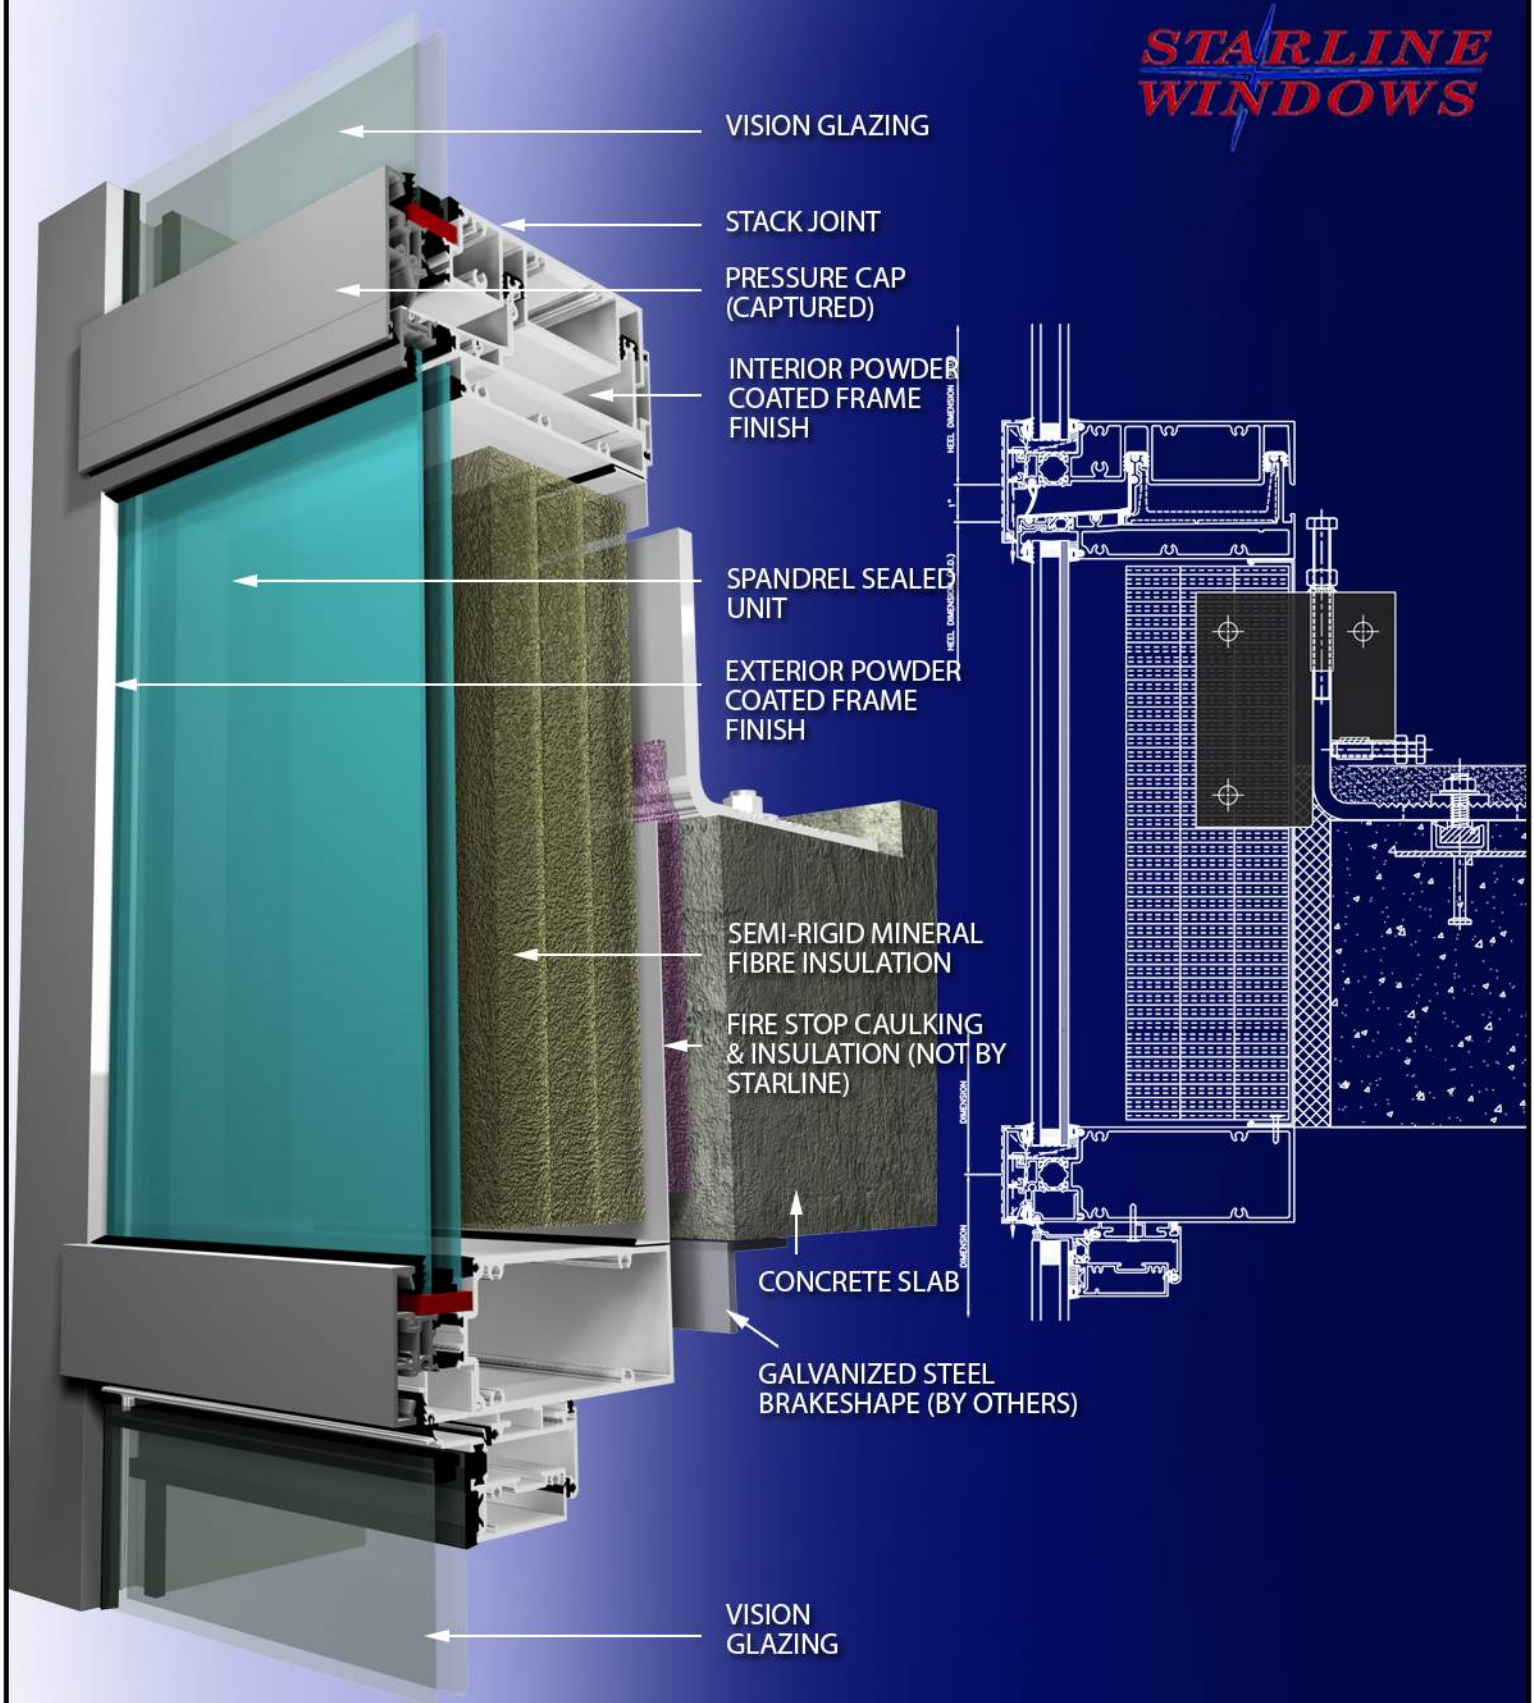
UCW - DWG 1

## UNITIZED CURTAIN WALL - HEAD, HORIZONTAL MULLION & SILL

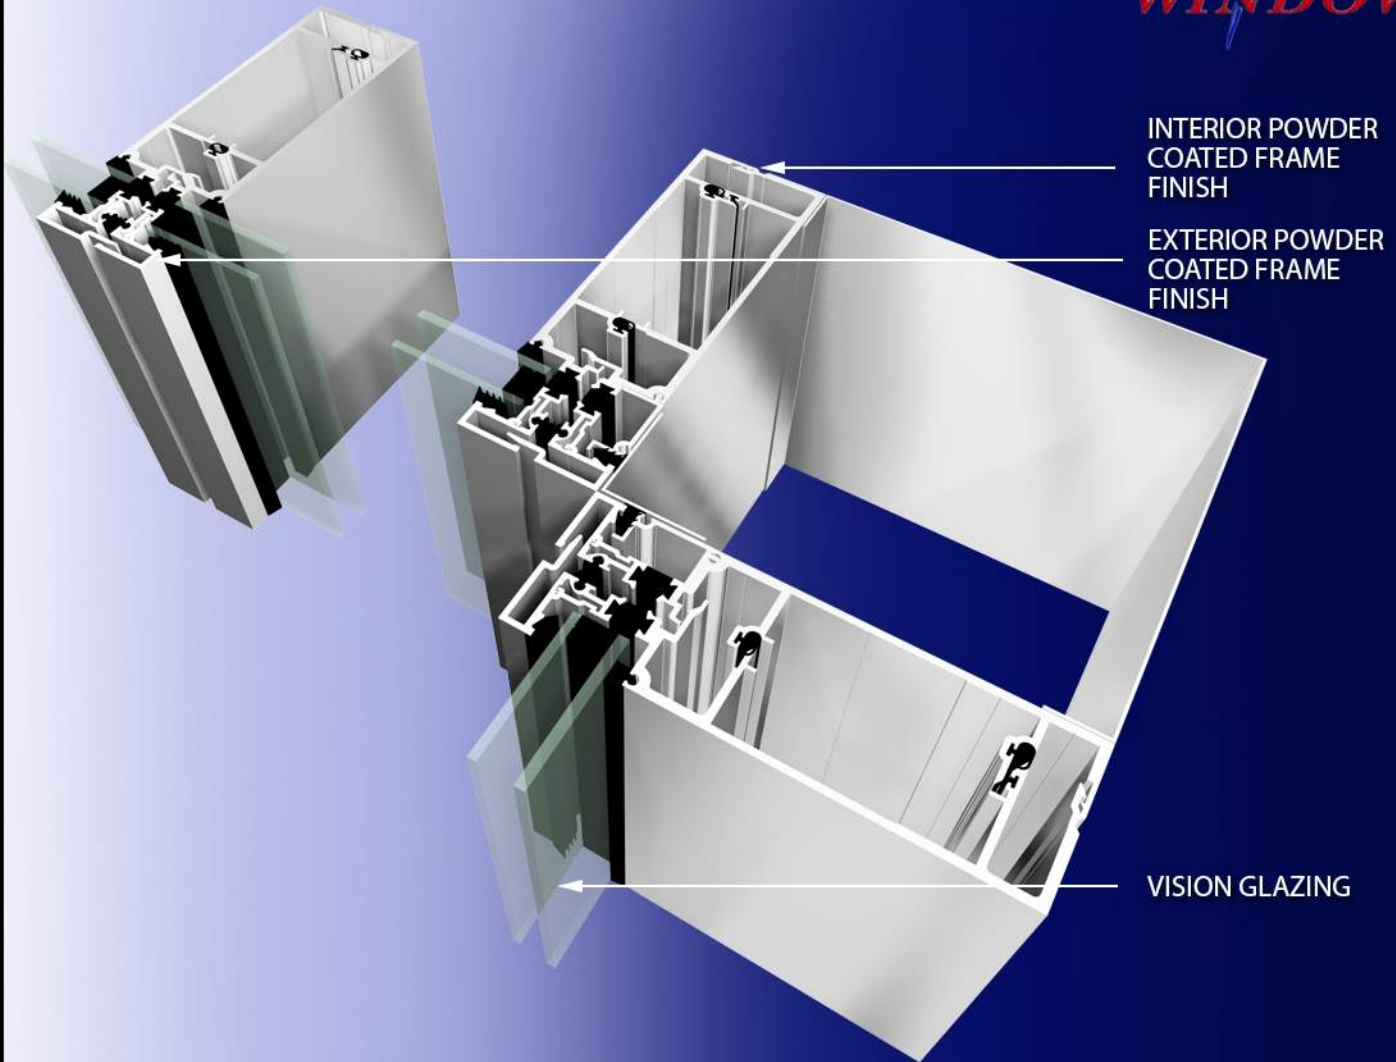
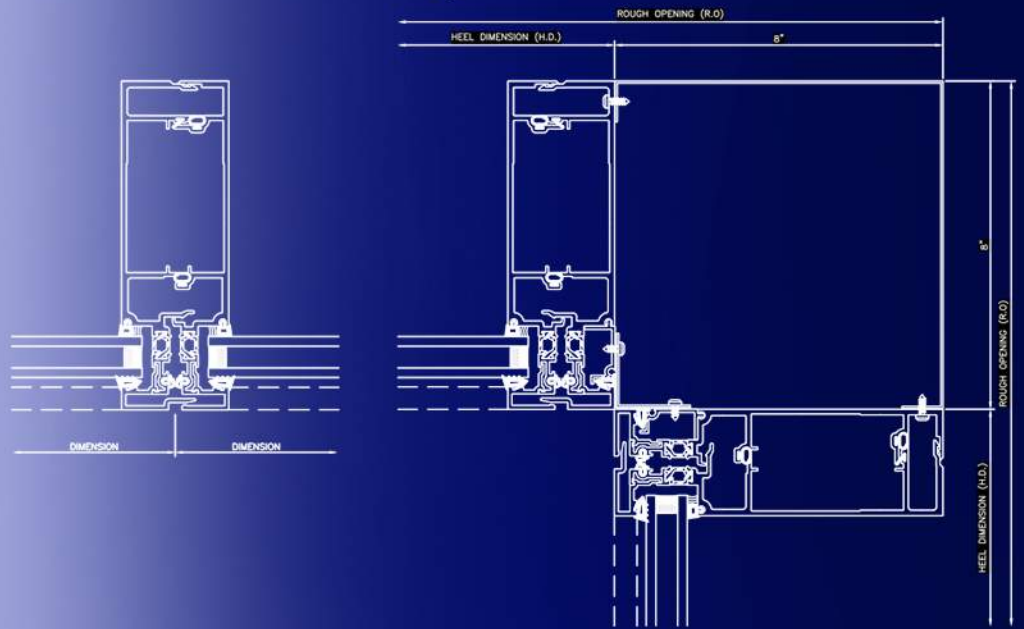
UCW - DWG 2

## UNITIZED CURTAIN WALL - STACKED JOINT & CAPTURED HORT. MULLION

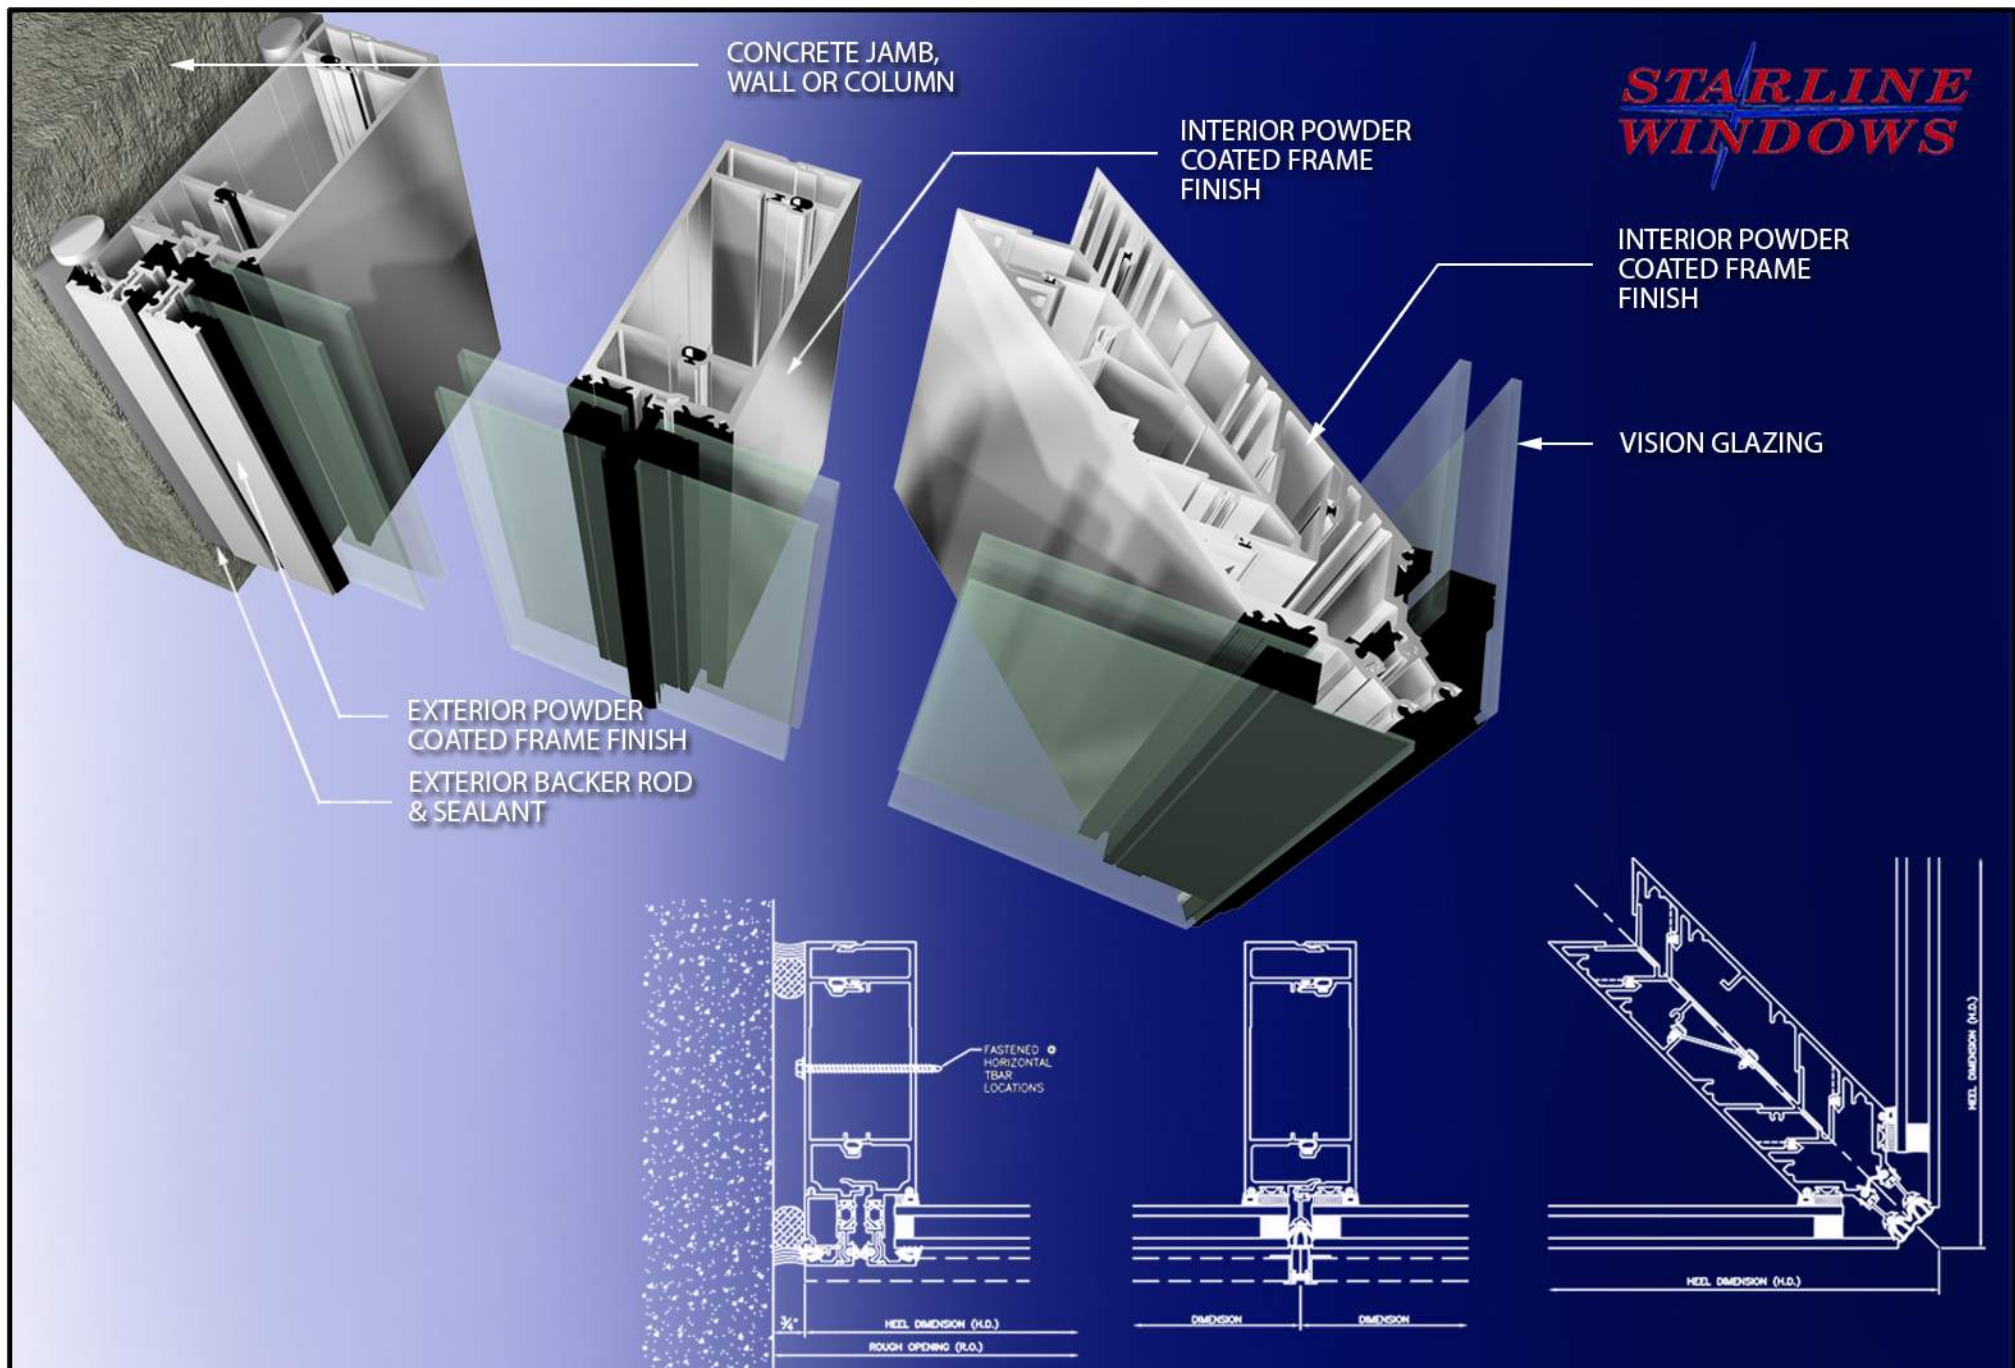
UCW - DWG 3

## UNITIZED CURTAIN WALL - CAPTURED COUPLER & 270 DEGREE CORNER COUPLER
