STARLINE WINDOWS

Series 9502 & 9503

Thermally Broken Aluminum Outswing Balcony Door

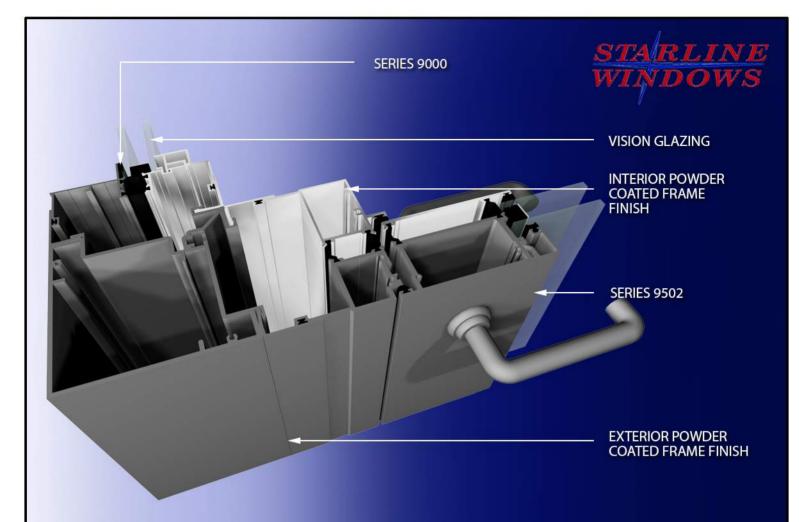
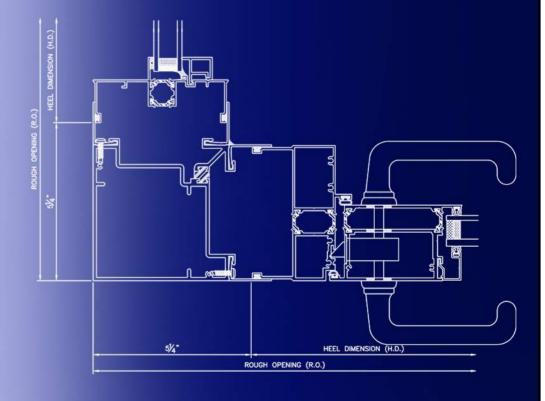
S.R.R.
 FEB. 2018
 9502 - DWG 4

## SERIES 9502 - 90 DEGREE SEISMIC CORNER COUPLER
